Brake Safety Week

August 25-31, 2024

10 Brake Lining and Pad Tips

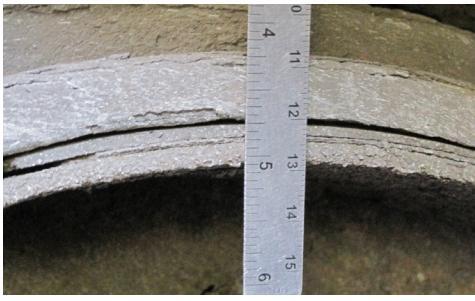
Worn out linings. **OOSC, Part II, a.(5)(c)vii** / 393.47(d)(2)-U.S.

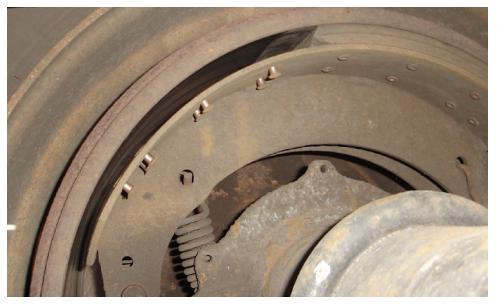
Missing lining block. OOSC, Part II, a.(5)(c)ii / 393.47(a)-U.S.

- 5. Ensure there are no missing lining blocks/pads.
- 6. Check for visible cracks or voids in the lining block.
- 7. Check for any exposed rivets or lining blocks that look loose on the shoe.

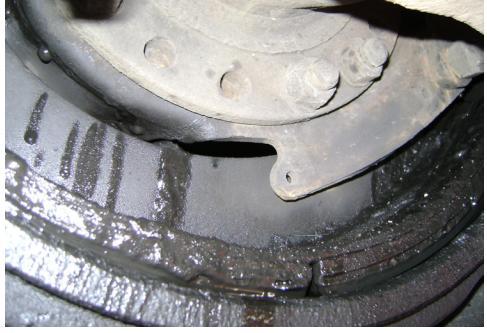
Contaminated lining. OOSC, Part II, a.(5)(c)vi / 393.47(a)-U.S.

- 3. Look at the shoe-to-drum clearance and ensure there is adequate lining on the shoe.
- 4. Look for any signs of leaks from the hub or other components that may be contaminating the lining/pad surface.

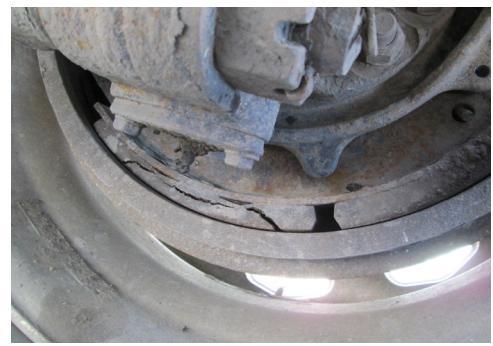
Cracked lining. OOSC, Part II, a.(5)(c)iii / 393.47(a)-U.S.

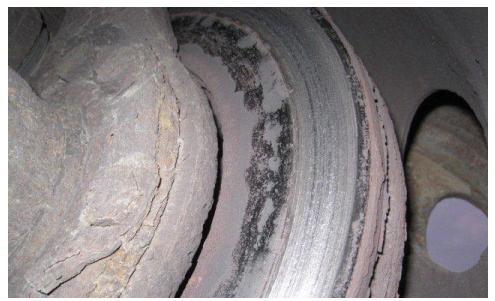
Metal-to-metal contact. **OOSC, Part II, a.(6)(c)** / 393.48(a)-U.S.

- 8. On disc brakes, pay particular attention to the condition of the rotor, such as heavily rusted rotors across the entire friction surface on either side or metal-to-metal contact.
